U.S. ARMY CORPS OF ENGINEERS - DETROIT DISTRICT

**PROPOSED ADVANCE MEASURES FLOOD CONTROL PROJECT
HAMPTON TOWNSHIP, BAY COUNTY, MICHIGAN
INTENSIVE ARCHAEOLOGICAL SURVEY**

**CONTRACT DACW-35-87-0-0009
DELIVERY ORDER #0001**

**CAMINOS ASSOCIATES
BAY CITY, MICHIGAN**

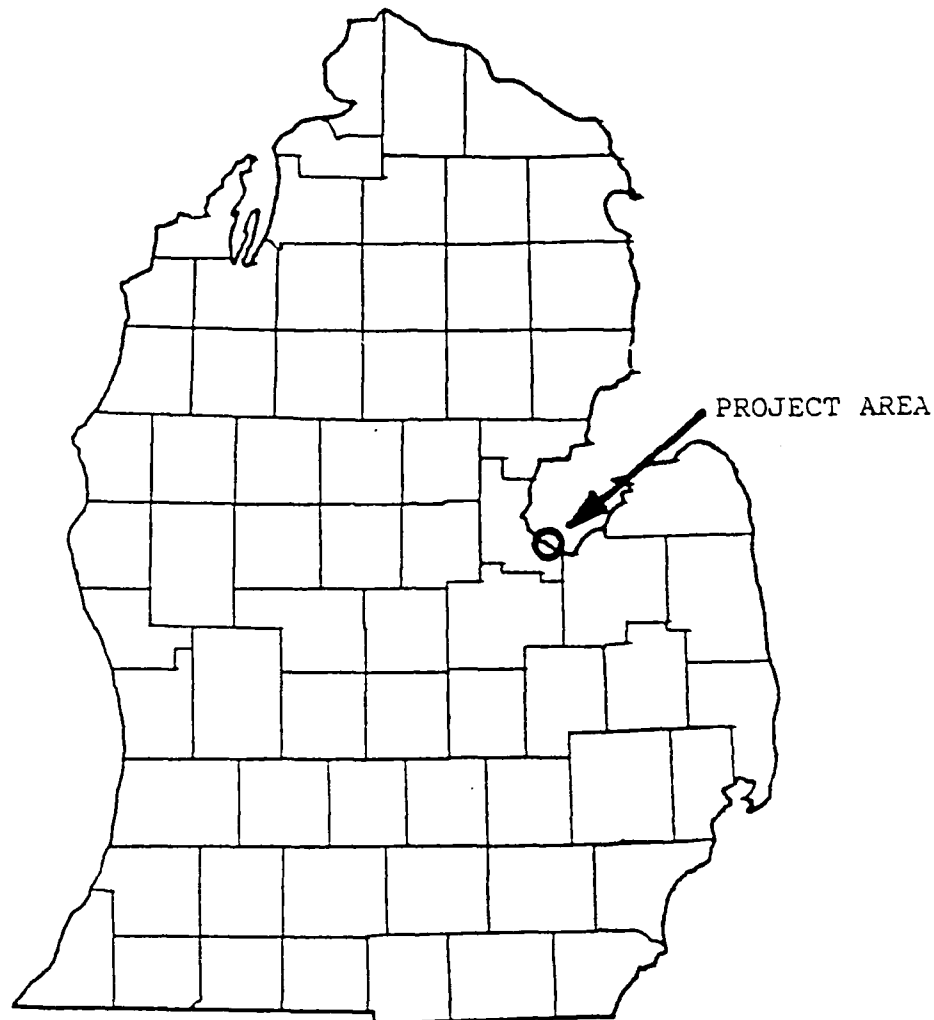
Figure 1: Map to Michigan Lower Peninsula showing location of project area.

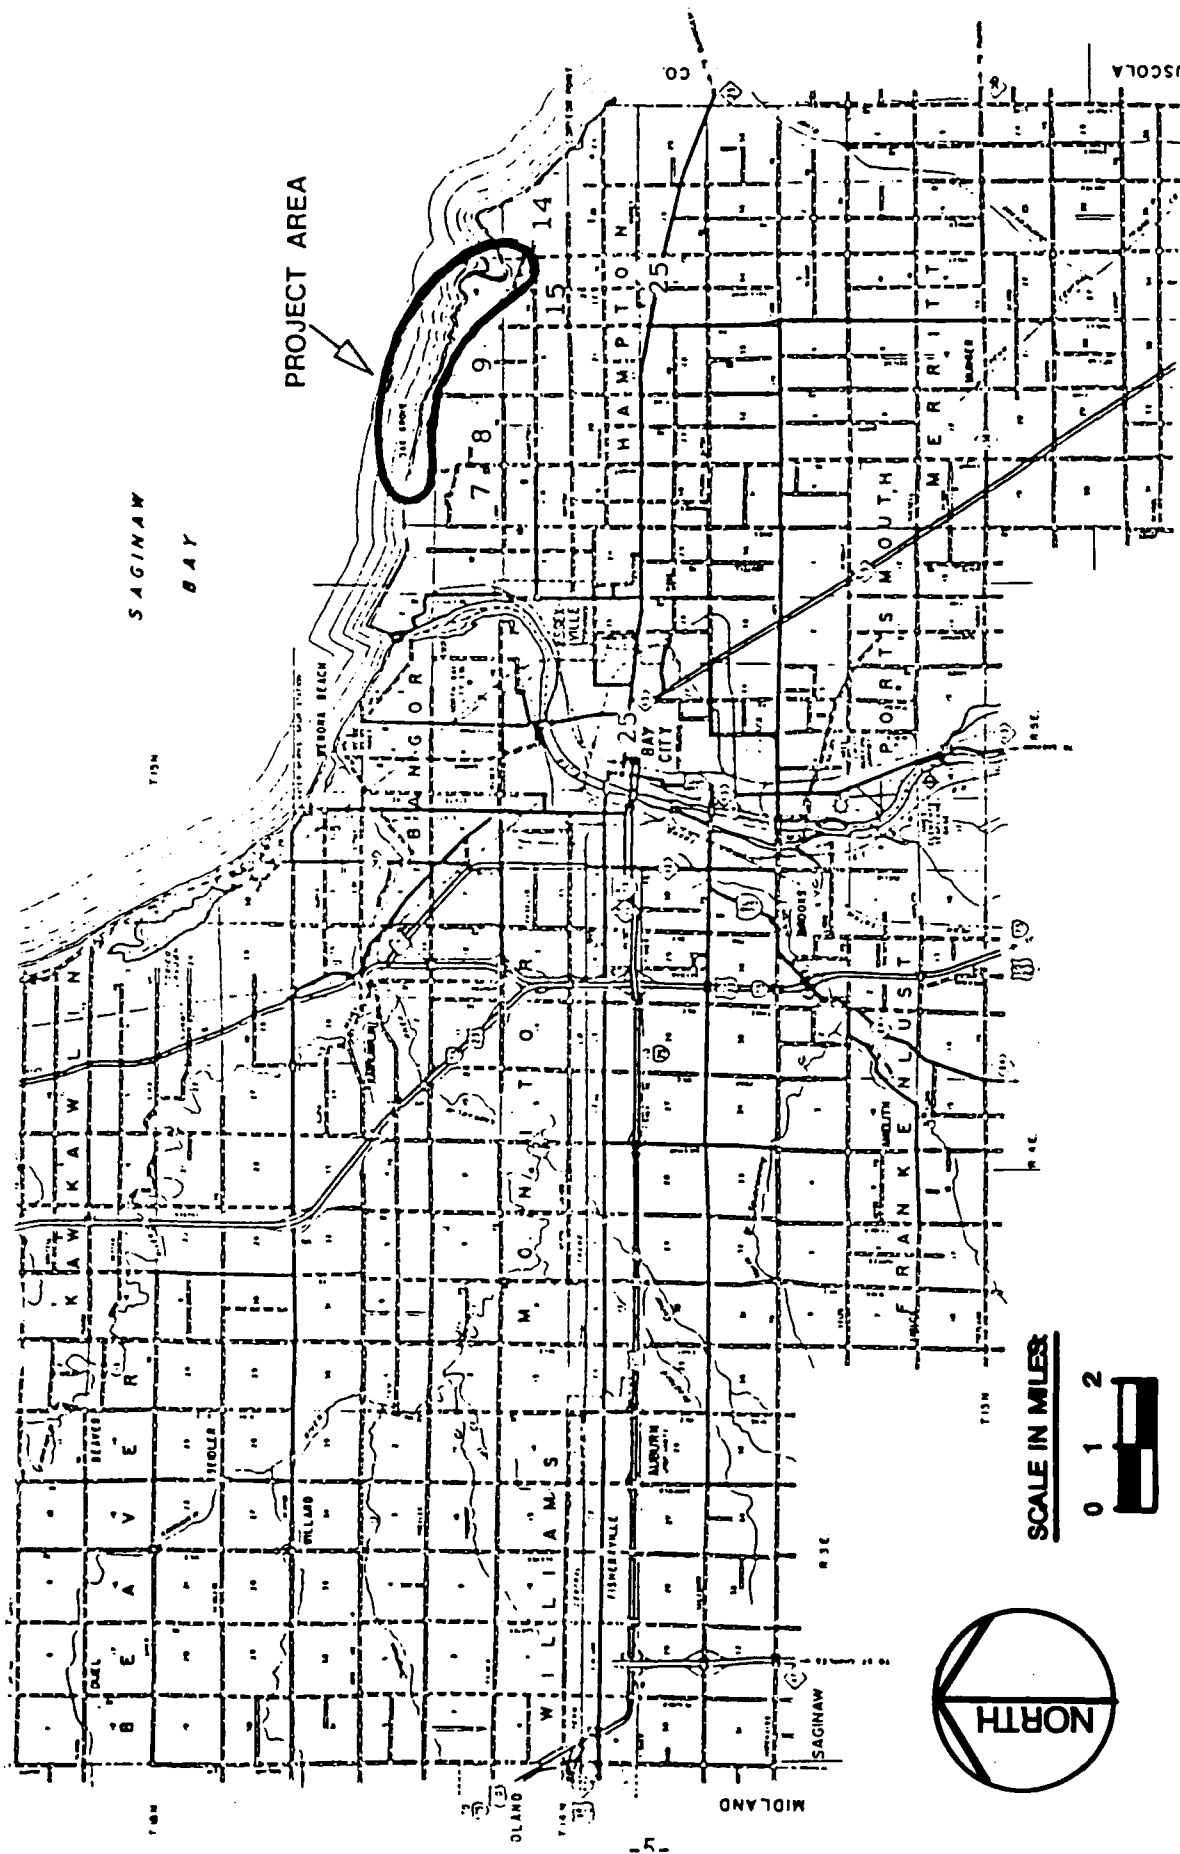
Figure: 2 Map of Bay County showing project area.

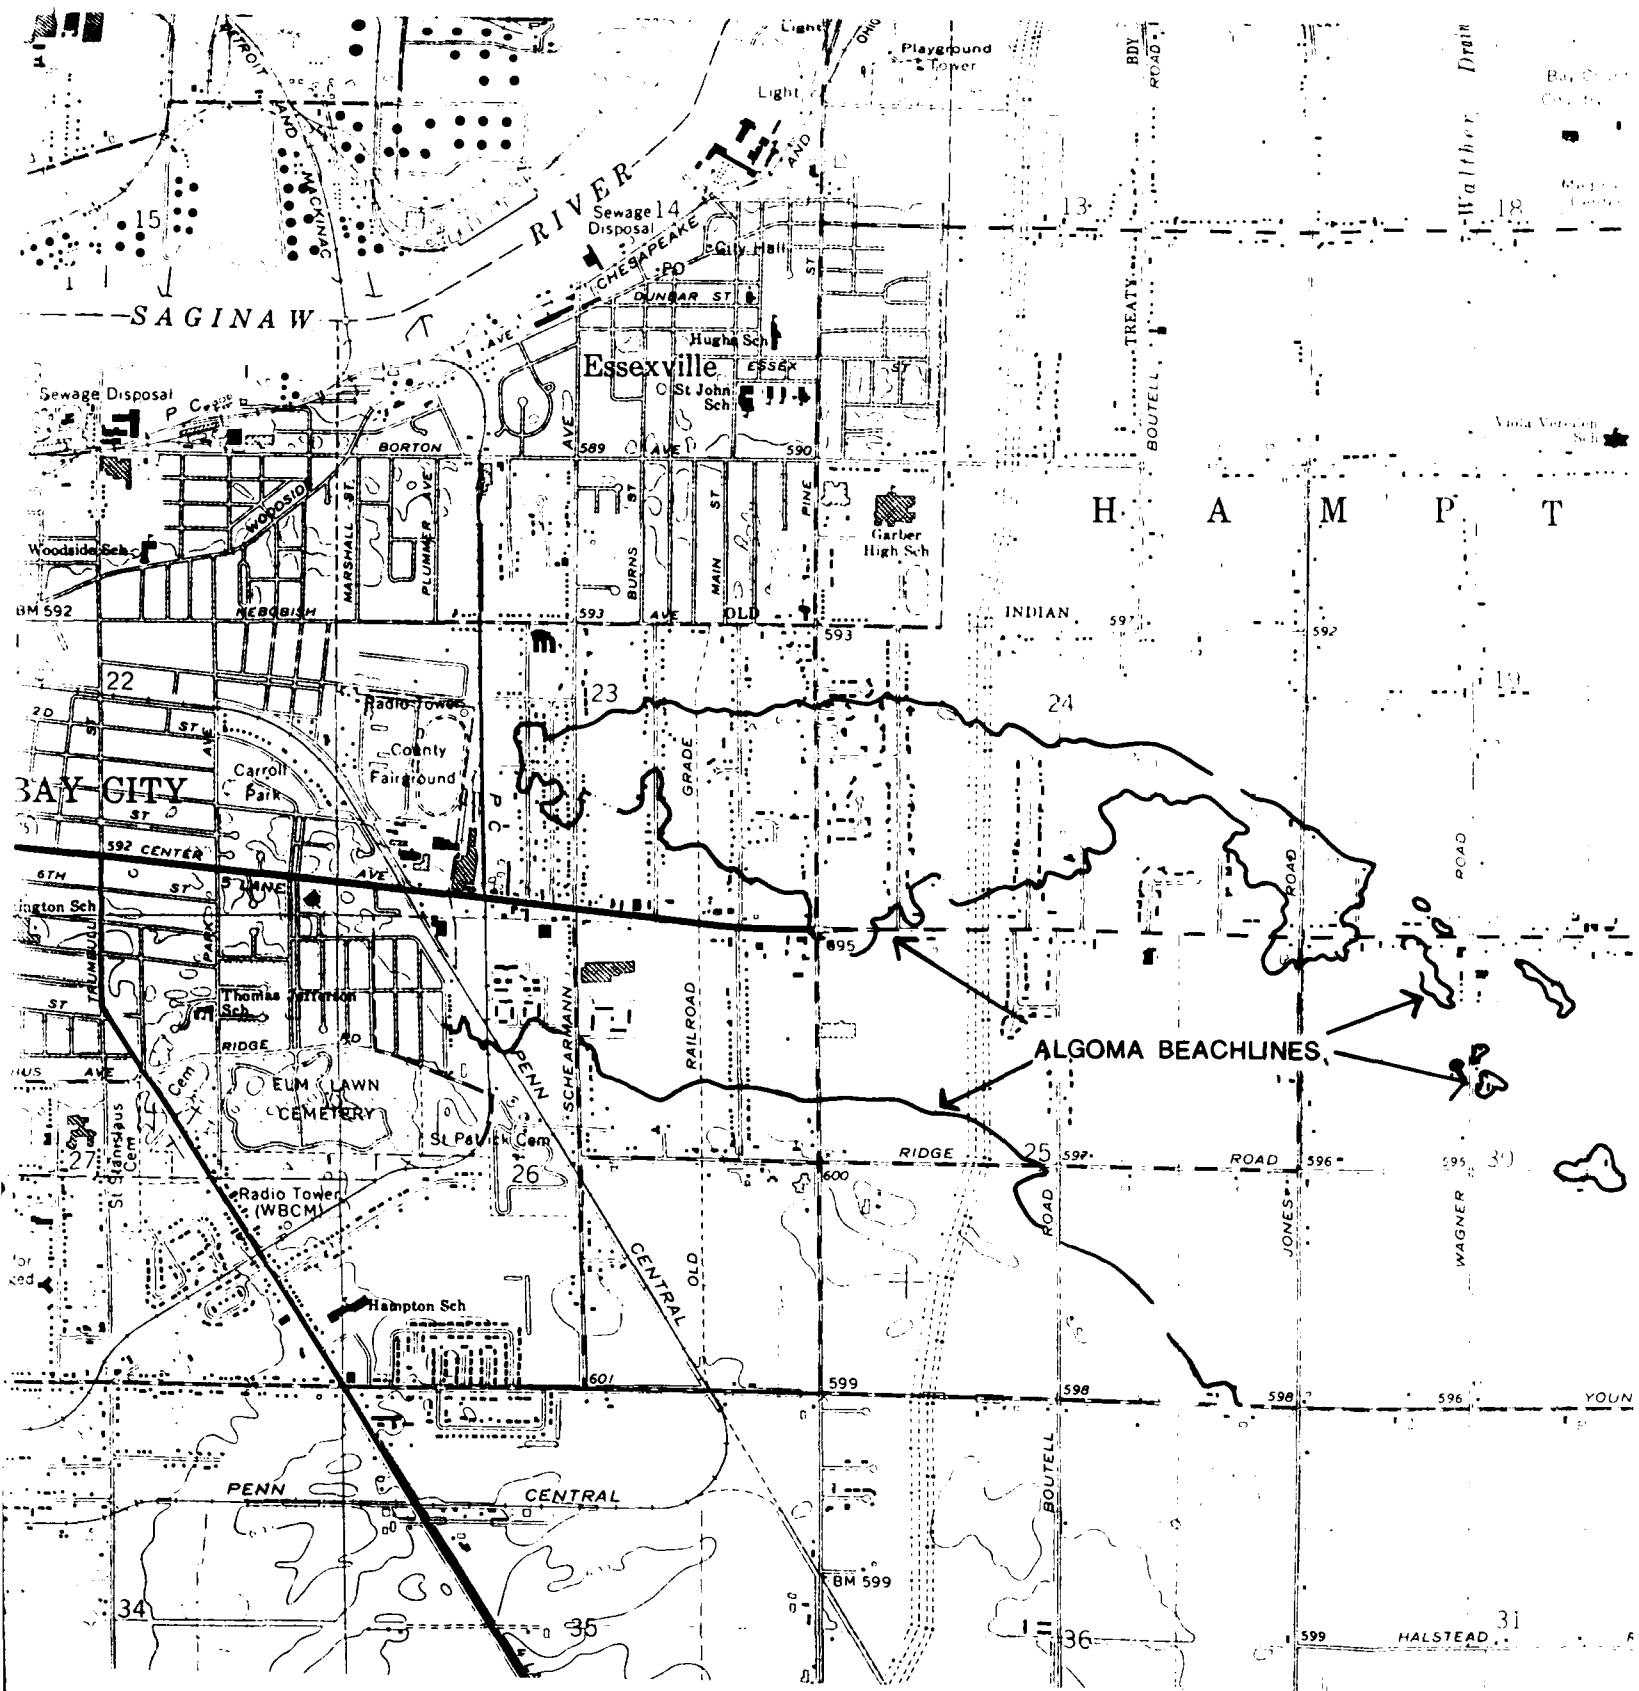
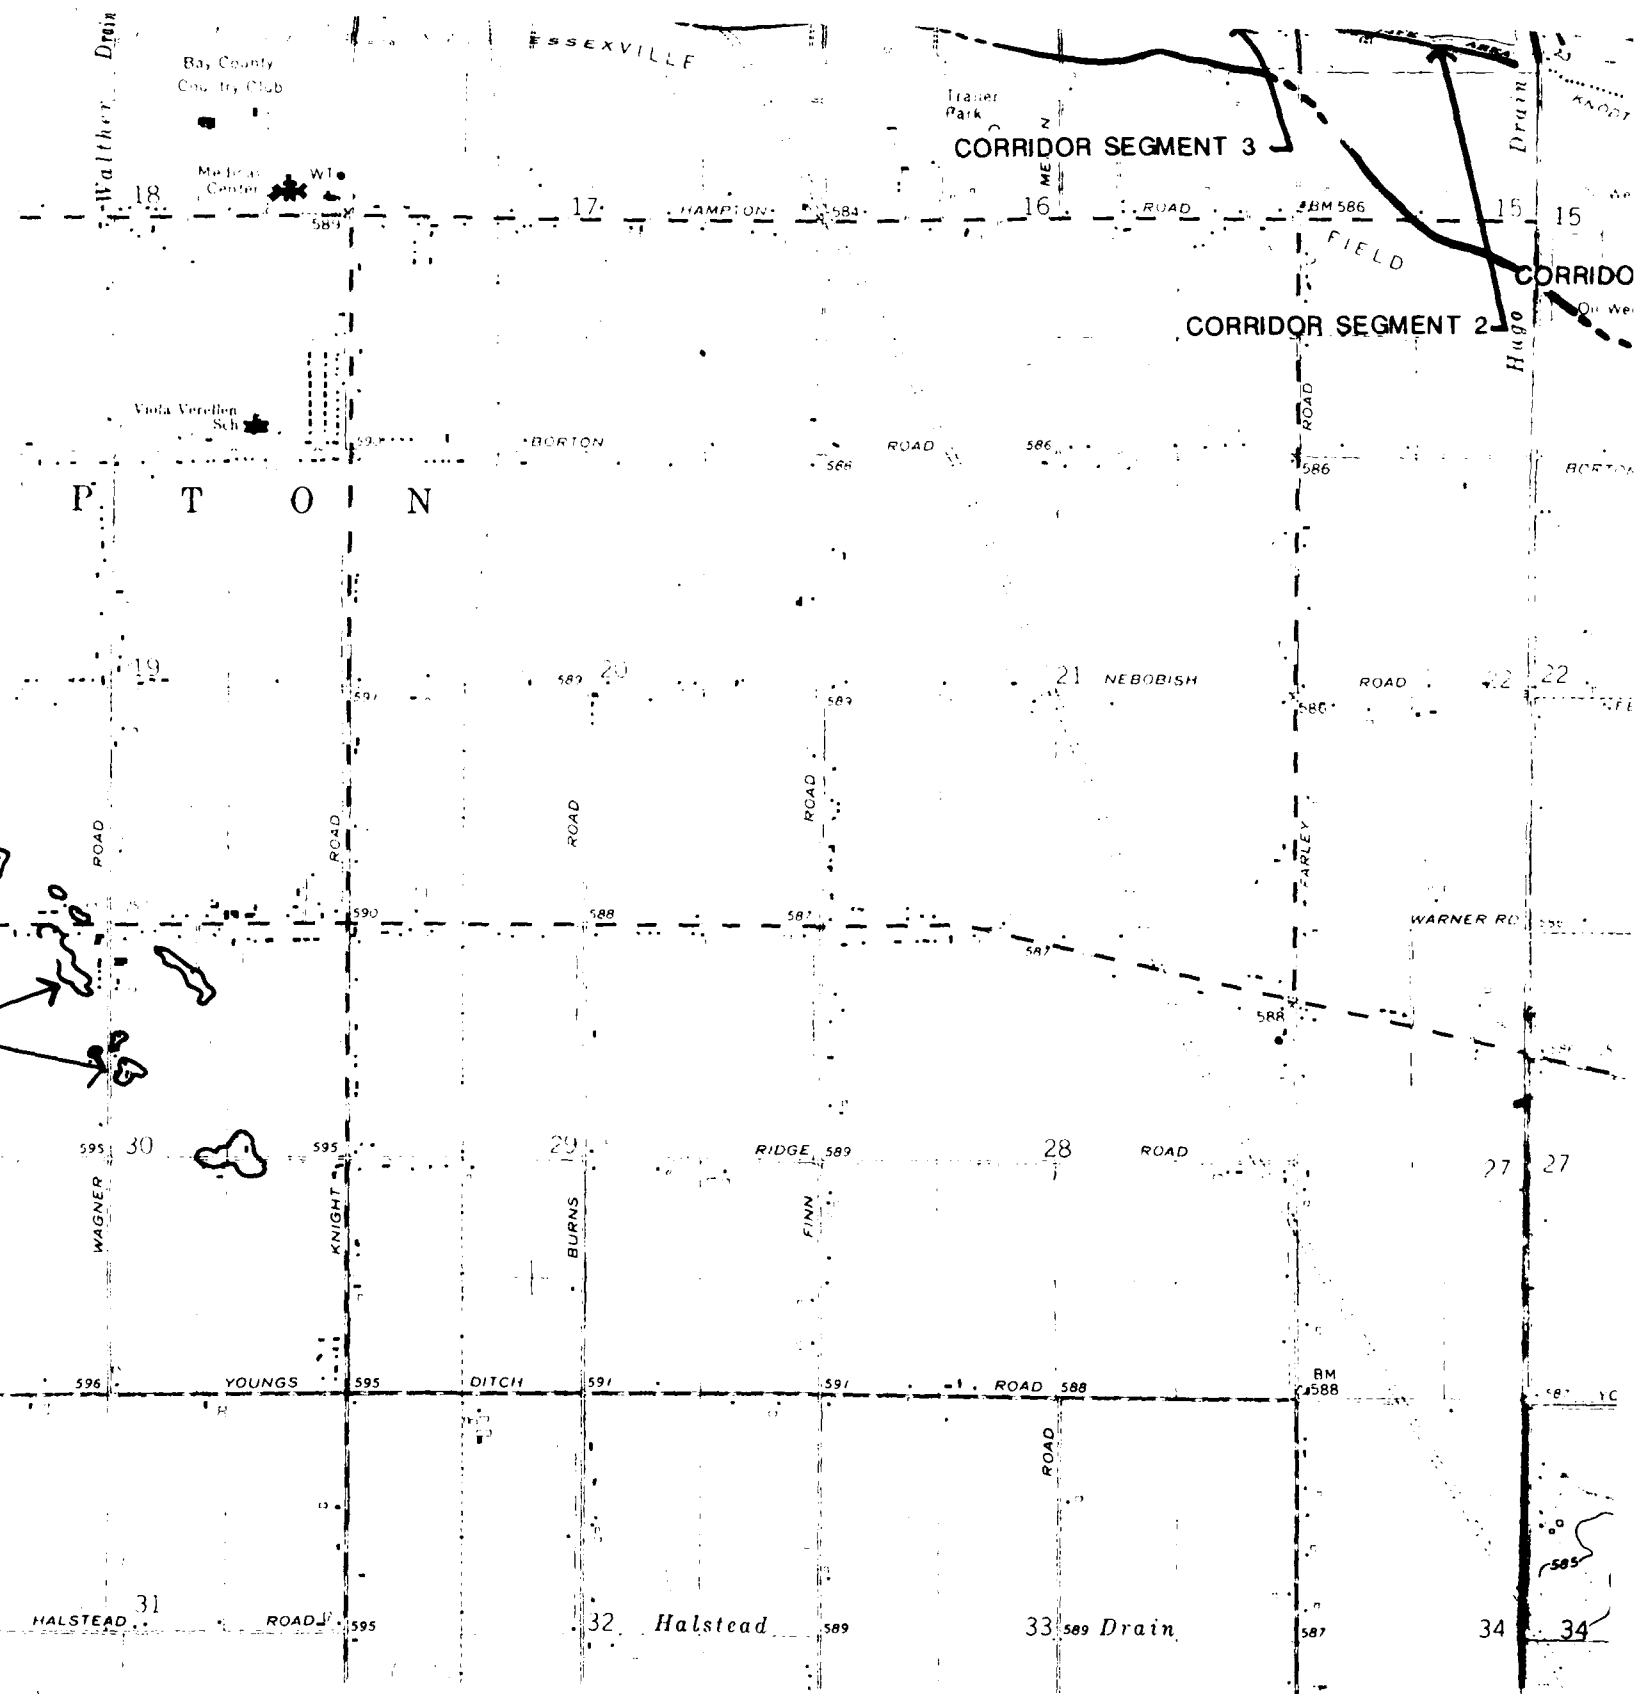
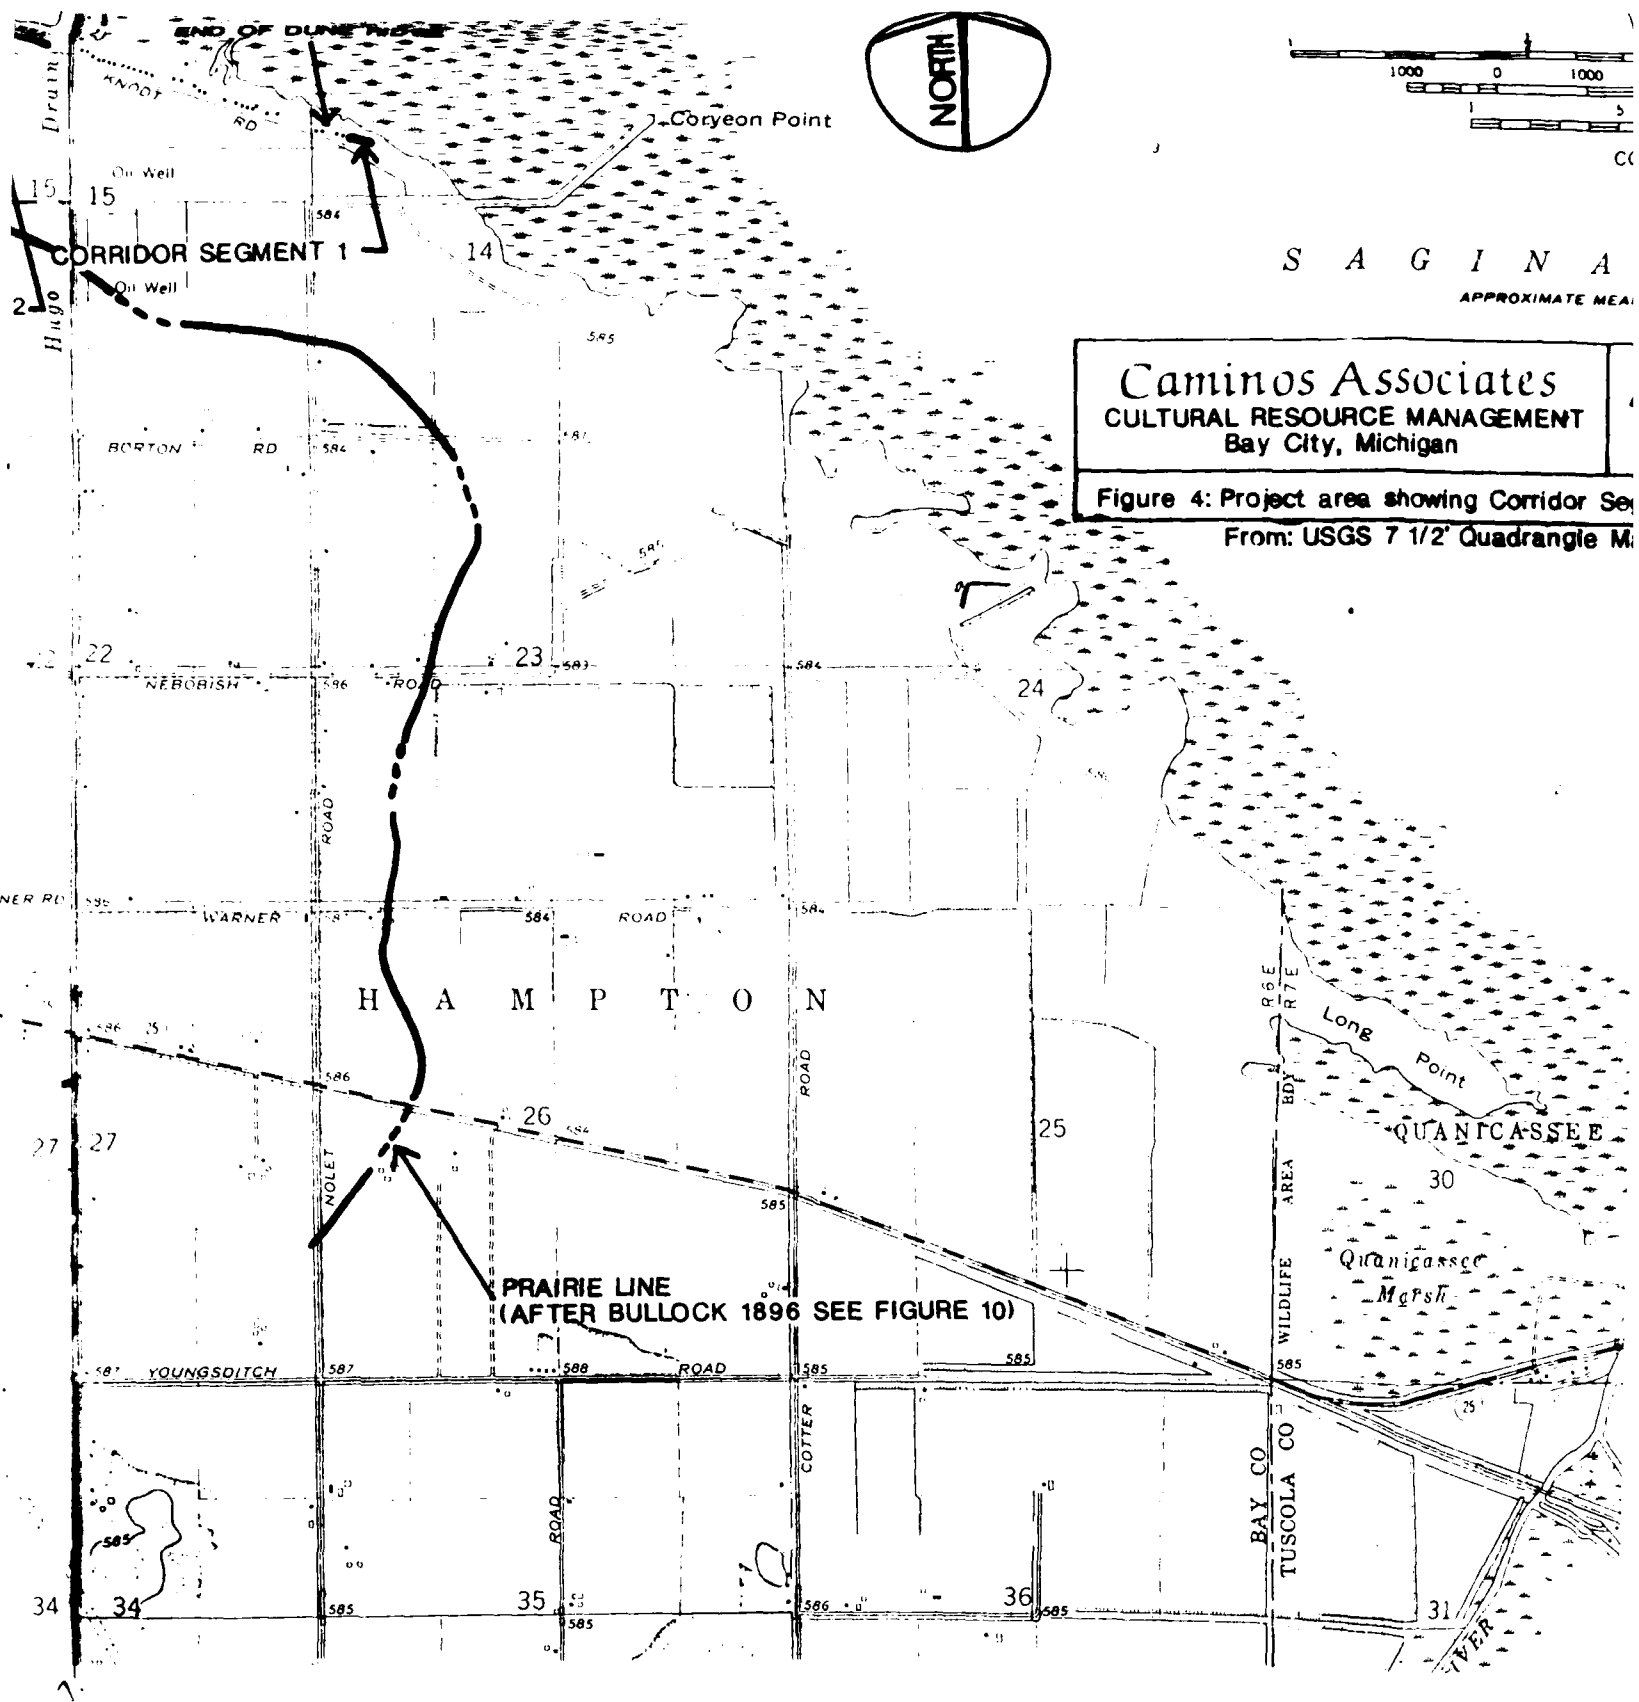
Figure 4: Project area showing Corridor Segment 1
From: USGS 7 1/2' Quadrangle Map

This corridor segment is the eastern end of the survey area on the Reckinger property (Figure 13). The area is composed of a beach sector along a long narrow offshore spit formation. This spit extending eastward lacks the dune or backbeach deposits found immediately to the west and its formation would necessarily postdate the lowering of water to the modern level approximately 2500 B.P. (500 B.C.).

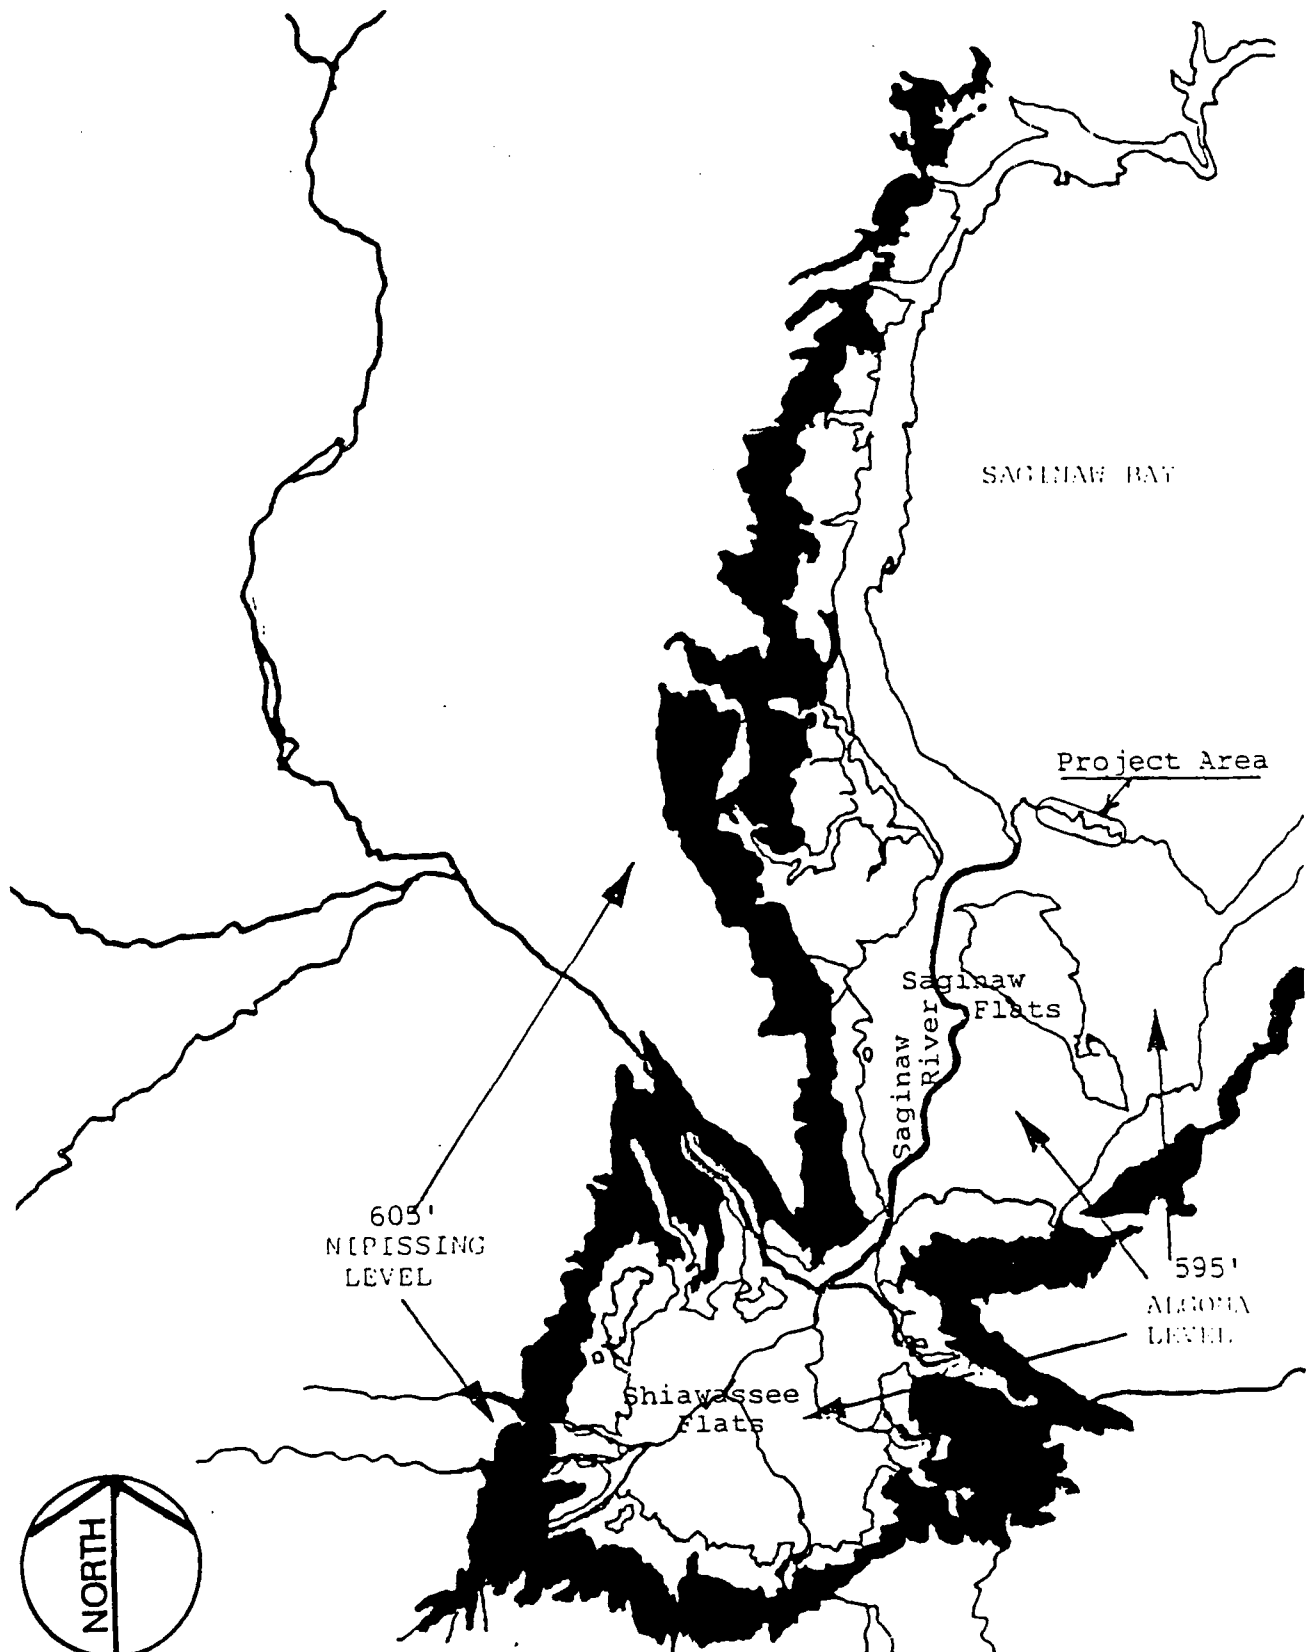
Figure 5: Regional map of Saginaw Valley showing physiographic zones.

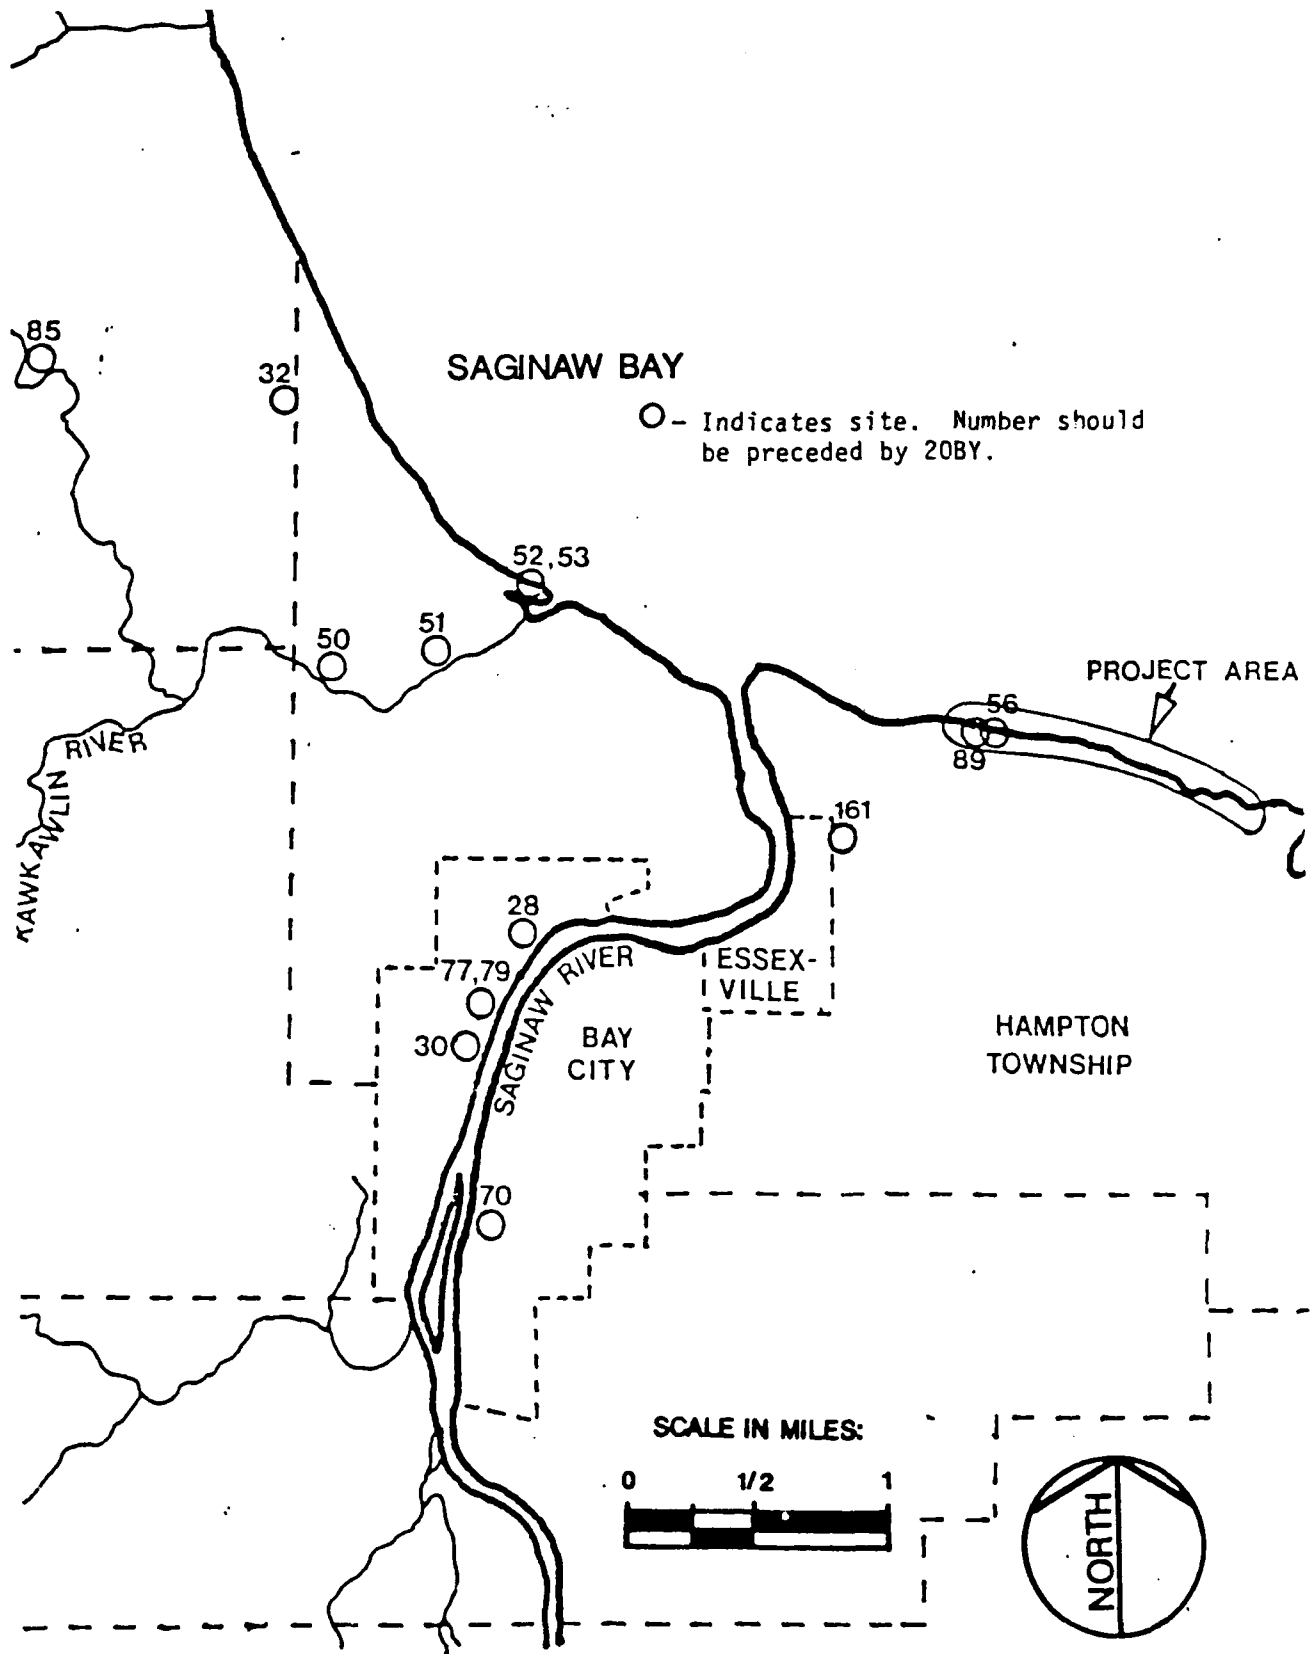
<p>Caminos Associates CULTURAL RESOURCE MANAGEMENT Bay City, Michigan</p>	<p>Advance Measures Flood Control Project, Hampton Township, Bay City, Michigan.</p>
<p>FIGURE 9: Prehistoric sites of the Bay City and Saginaw Bay regions</p>

Figure 9 shows the distribution of prehistoric sites in the Bay City area. Most of these have Late Woodland components such as the Fletcher site 20BY28 and the Trombley House site 20BY70. Two sites probably of late Woodland origin, from the near vicinity of the project area are noted on Michigan Bureau of History (BOH) site files. They are also indicated on Figure 9 as sites 20BY56 and 20BY89. The former, located on the Hughes property in the vicinity of Oak Grove, is listed as a cemetery and is also the location of a cache. Site 20BY89 is listed as a prehistoric site of undetermined occupation.

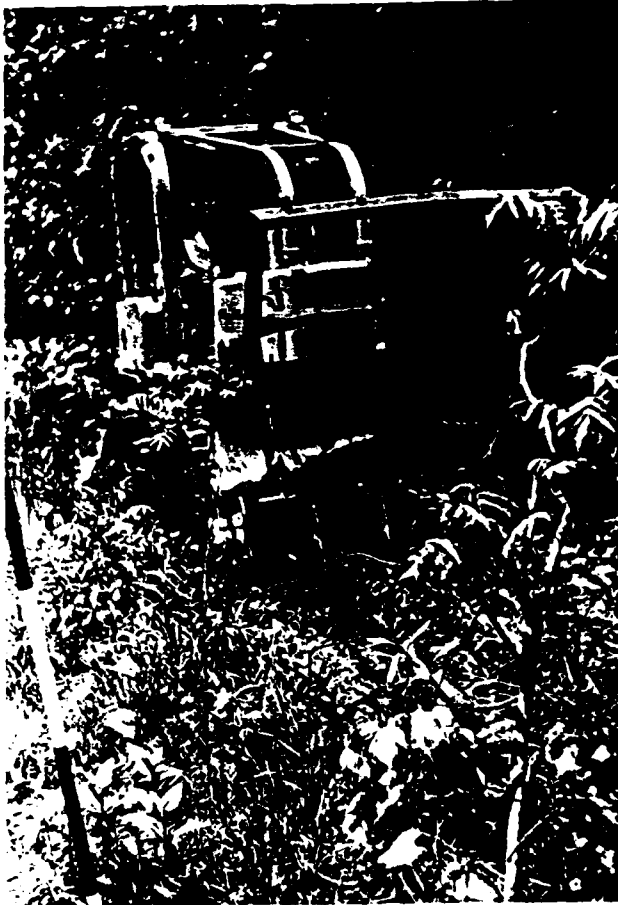
Plate 1A: Grubbing operation
showing root rake. Machine
operator: Ralph Howe.

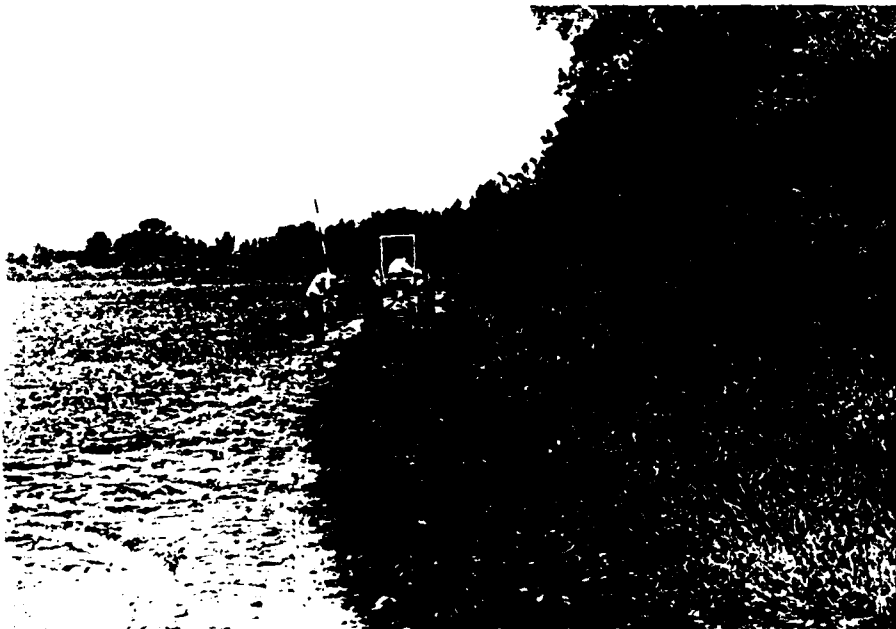
Plate 1B: Disking operation. Tractor operator: Jim Johnson

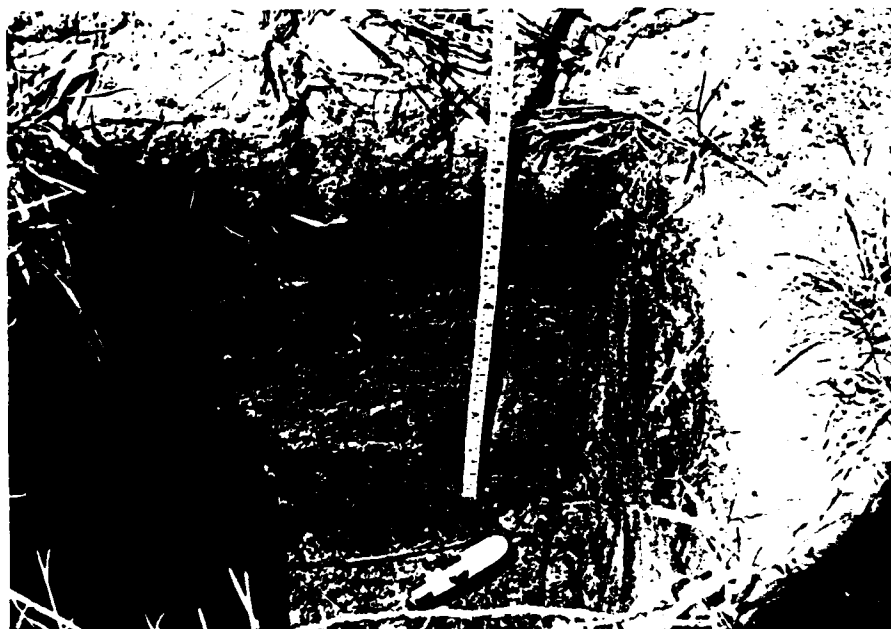
Plate 3A: Profile of shovel test unit # 1, corridor segment # 1.
Shovel test transect.

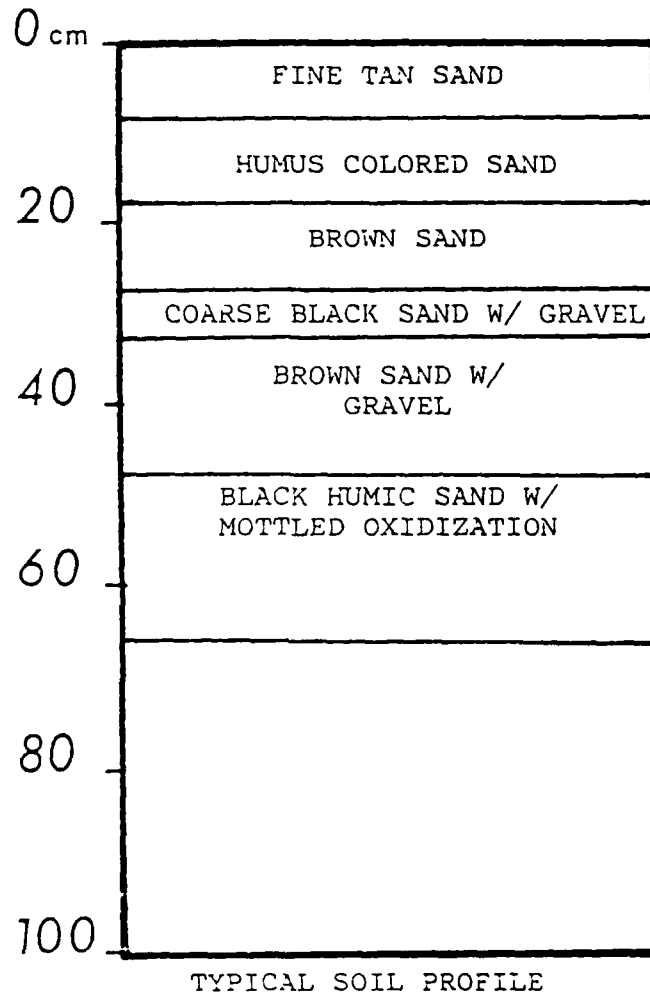
Camino's Associates CULTURAL RESOURCE MANAGEMENT Bay City, Michigan	Advance Measures Flood Control Project, Hampton Township, Bay City Michigan.
Figure 14: Typical profile of stratigraphy at corridor segment 1.

Pedestrian survey, as well as disking and shovel testing operations were accomplished on May 27, 1987 by crew members walking and examining the corridor segment and machine transect. The transect was again surveyed on June 1, by similar pedestrian survey. Disking produced no evidence of cultural material. Occasional pieces of road or fill gravel were noted mixed in the sand matrix. At the western portion of the transect patches of humus colored or silt laden sands were noted. The easternmost of these was determined to derive from buried soil zone 2 while 3 similar areas to the west were thought to be remnants of a basal humic zone exposed at the water's edge and in shovel test units (Figure 14).

Shovel testing on May 27, 1987, revealed fairly homogeneous stratigraphic relationships the length of the shovel test transect. A standard profile reveals below the recently deposited top sands and humus colored zones separated by tan sands (Figure 14, Plates 2A and 2B). The basal zone at the beginning of the water table is a compact humic zone representing the original vegetation of a wetland or offshore marsh. It is this strata that is exposed in discontinuous fashion at the water's edge. The two upper dark zones could represent periods of stabilization and vegetation cover. This is unlikely since little organic material appears in these strata. They are more likely deposits of silt derived from the basal zone as it was eroded by high water wave action and deposited landward. This interpretation would account for the historical material found in shovel test unit 1. A harness buckle was recovered from below the first humus colored layer and a fragment of leather strap recovered just above the basal humic zone in this unit.
